CONTENTS

Lesson learned documentation sheet

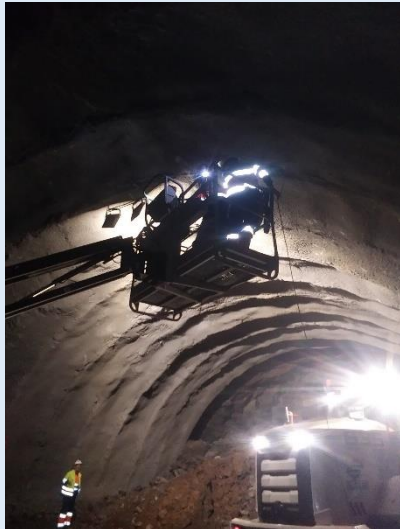
LESSON NO.1: Dropped tools while using Mobile Elevating Work Platforms (MEWP)

| Event description | Tools dropped from a Mobile Elevating Work Platform (MEWP) |
| Causes | <p>Inappropriate tool use. Placing hand tools in inappropriate spots. Lack of tool fastening to prevent them from falling</p> |

| Lessons learned | <p>Signposting and marking off of the working radius for MEWP works Order and proper use of tools on MEWP. Use of tool holders.</p> |

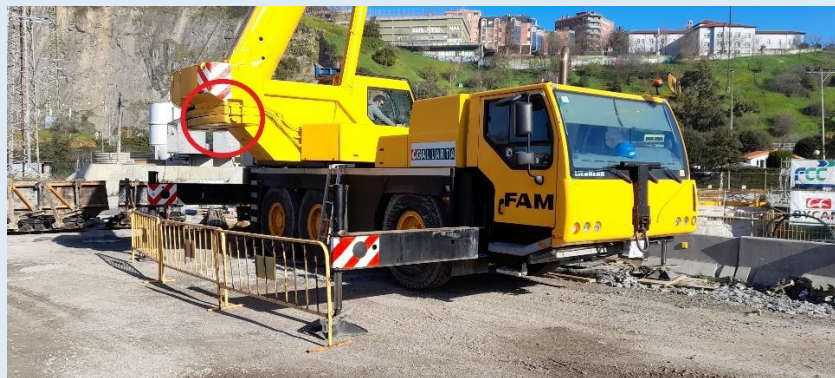
LESSON NO.2: Dropped counterweights from self-propelled crane

Event description Failure of bolts securing counterweights on self-propelled crane.

Causes Mechanical failure. Poor condition of the bolt securing the counterweights.

Lessons learned Perimeter marking to prevent people from passing through.
Initial crane safety element check.

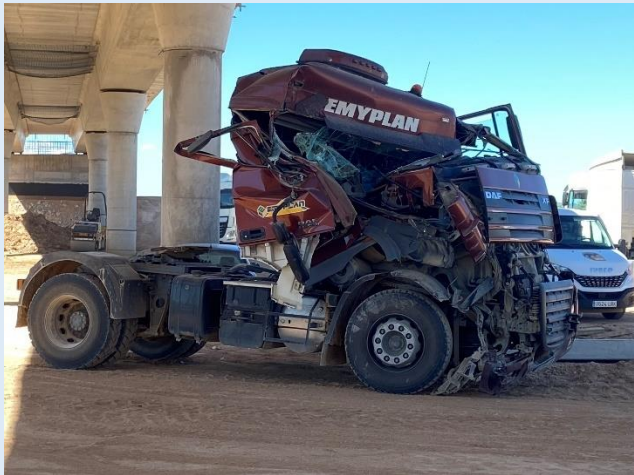
LESSON NO.3: Collision between moving vehicles

| <p>Event description</p> | <p>Slight collision between tanker and reversing dumper lorry.</p> |
| <p>Causes</p> | <p>Recklessness of the lorry driver in stopping without observing the distance to the dumper. Recklessness on the part of the dumper driver for failing to give advance indication of the operation or checking for vehicles next to him.</p> |

| <p>Lessons learned</p> | <p>Importance of observing safety distances. Provision of rear-view cameras on this type of machinery.</p> |

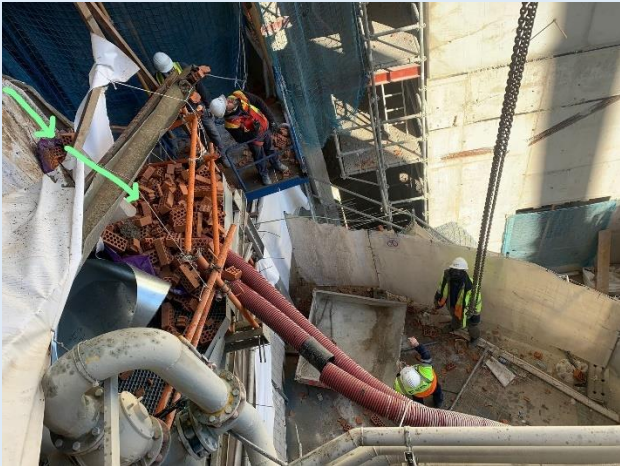
LESSON NO.4: Inappropriate pallet transport

| <p>Event description</p> | <p>Dropped material caused by pallet breakage during crane lifting manoeuvre.</p> |
| <p>Causes</p> | <p>Failure to handle loads with the appropriate devices, using slings when they should be transported with pallet forks.</p> |

| <p>Lessons learned</p> | <p>Use the appropriate tools for moving loads.</p> |

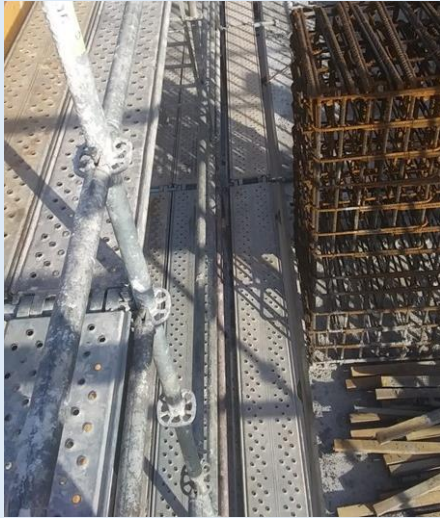
LESSON NO.5: Dropped material during manual loading

| <p>Event description</p> | <p>Dropped load while being handled by workers.</p> |
| <p>Causes</p> | <p>The load was too heavy for the number of workers engaged in the operation.</p> |

| <p>Lessons learned</p> | <p>The maximum weight to be handled by workers must be taken into account. Teams of workers shall be adequately sized in number.</p> |

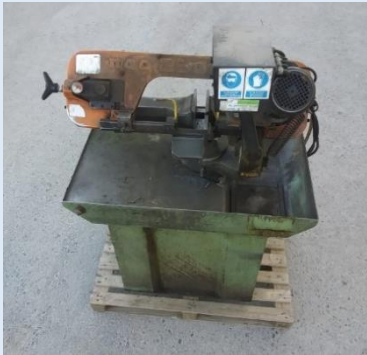
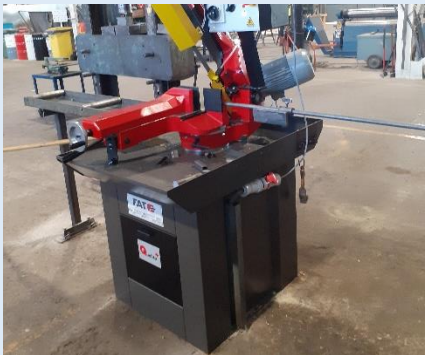
LESSON NO.6: Machinery malfunction

| <p>Event description</p> | <p>Abrupt and unexpected stops of a saw in the workshop.</p> |
| <p>Causes</p> | <p>FAT Bandsaw malfunction.</p> |

| <p>Lessons learned</p> | <p>Remove the machine and purchase another one if necessary. An external company was commissioned to conduct an additional overhaul of all machines in the workshop.</p> |

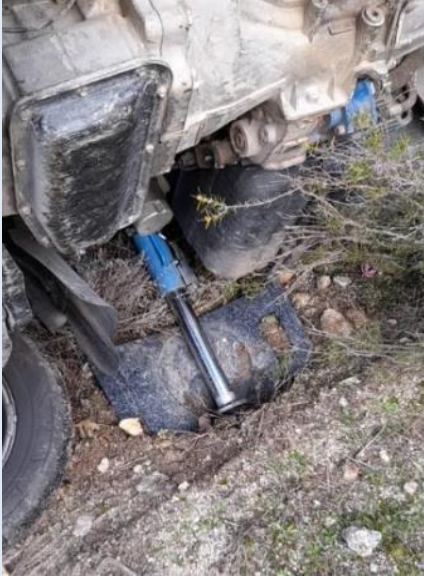
LESSON NO.7: Overturned lift basket caused by an outrigger collapse

| Event description | Overturned lift basket caused by collapsed and slipped outriggers. |
| Causes | Failure to check the condition of the ground on which the outriggers were set up. Not having elements to extend the support surface of the stabilisers if necessary. |

| Lessons learned | Preliminary analysis before carrying out work with baskets Extend the base area of outriggers whenever the ground conditions raise doubts about the load-bearing capacity. |

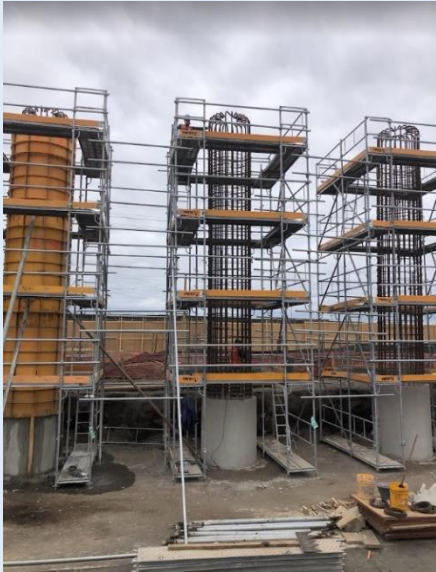
LESSON NO.8: Non-compliance with the Heavy Lifting Plan

| <p>Event description</p> | <p>The self-propelled crane was unable to lift and move pile reinforcement.</p> |
| <p>Causes</p> | <p>The crane was positioned differently from how it was intended in the Lifting Plan.</p> |

| <p>Lessons learned</p> | <p>Prior analysis of crane positioning. Marking of the positioning spot.</p> |

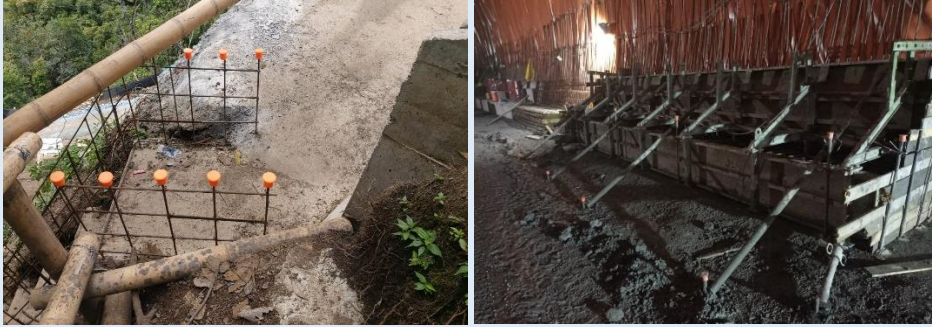
LESSON NO.9: Overconfidence

| <p>Event description</p> | <p>Worker walking on an unstable surface with risk of falling on rebar.</p> |
| <p>Causes</p> | <p>Lack of risk perception and overconfidence in the passage area. Failure to protect protruding beam rods, lack of supervision.</p> |

| <p>Lessons learned</p> | <p>Awareness-raising talks on existing risks. Increased field supervision.</p> |

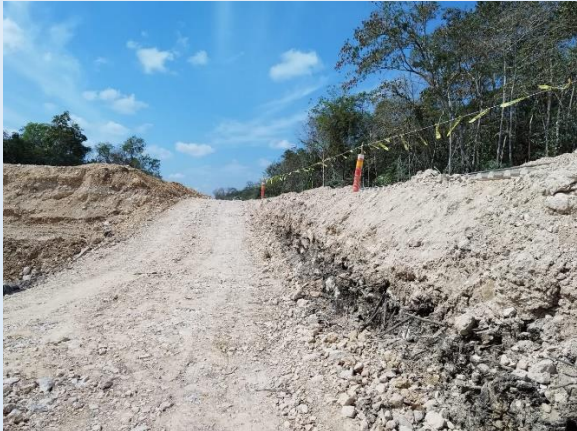
LESSON NO.11: Riesgo de sepultamiento

| Event description | While dumping material, some of it accidentally fell on a worker. |
| Causes | Standing in or passing through dangerous areas. Carelessness or inattention, overconfidence. Lack of or inadequate planning. |

| Lessons learned | After analysis of the dumping, backfilling and compaction works. Development of work procedures to minimise risks to workers. |

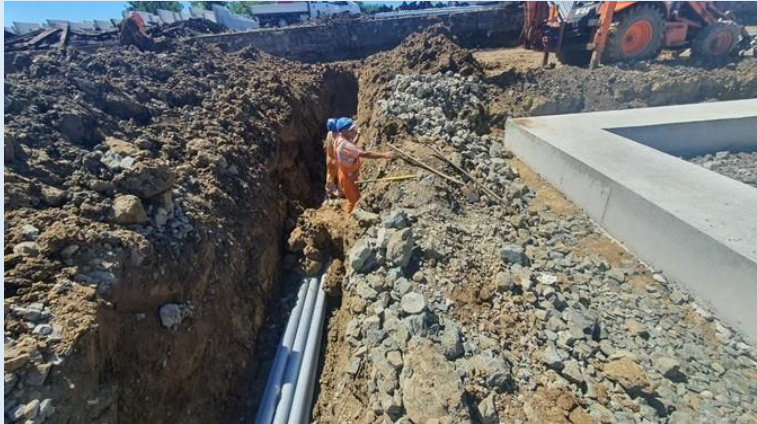
LESSON NO.13: Improperly stacked excavation material

| <p>Event description</p> | <p>Personnel working in a 1.5 – 3.0 metre deep excavation with the presence of material from the excavation next to the edge, with a risk of falling material.</p> |
| <p>Causes</p> | <p>Material from the excavation stacked next to the edge.</p> |

| <p>Lessons learned</p> | <p>Material from excavation must be piled at least 1 metre from the edge. Avoid overloading the slope edge.</p> |

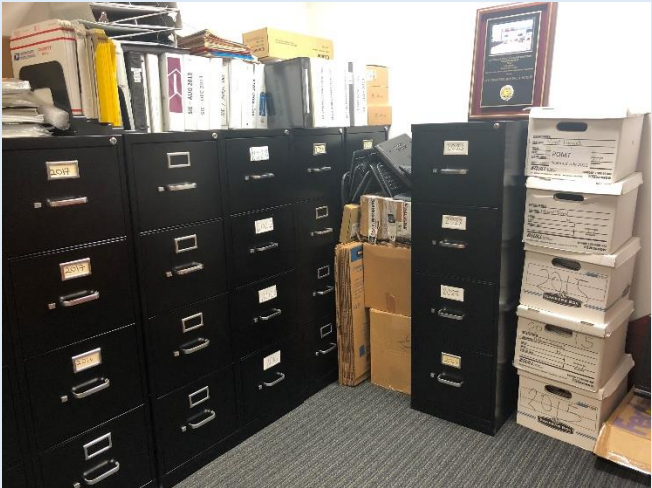
LESSON NO.14: Lack of space to organise documents

| <p>Event description</p> | <p>Office material fell when a worker was looking for documentation in the storage area.</p> |
| <p>Causes</p> | <p>Reduced storage space. Lack of order.</p> |

| <p>Lessons learned</p> | <p>Have a storage area of sufficient size for the correct placement of office material.</p> |

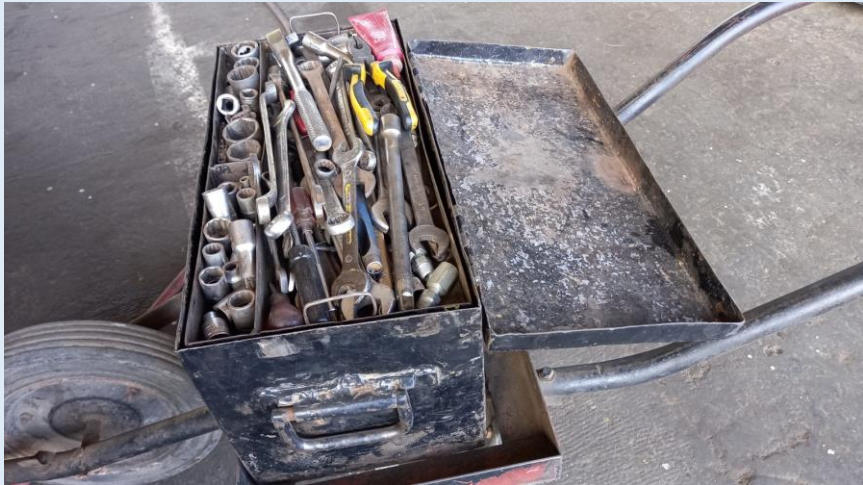
LESSON NO.15: Near-accident when handling a toolbox

| <p>Event description</p> | <p>Sudden and abrupt closing of the toolbox lid when the worker was storing the keys.</p> |
| <p>Causes</p> | <p>The lid was not completely open when a gust of wind occurred. The toolbox lacks a device to prevent the lid from closing abruptly.</p> |

| <p>Lessons learned</p> | <p>Awareness of the risks present in the workshop area of the equipment depot. Check and ensure that the lid must be fully open.</p> |
